Broadcast Products Technical Bulletin 20-2005-034

DATE: **March 28, 2005**SUBJECT: **CARTRIDGE CANNOT BE DETECTED AFTER
LOADING**

MODEL: **PDW-510
PDW-510P
PDW-530
PDW-530P
PDW-V1**

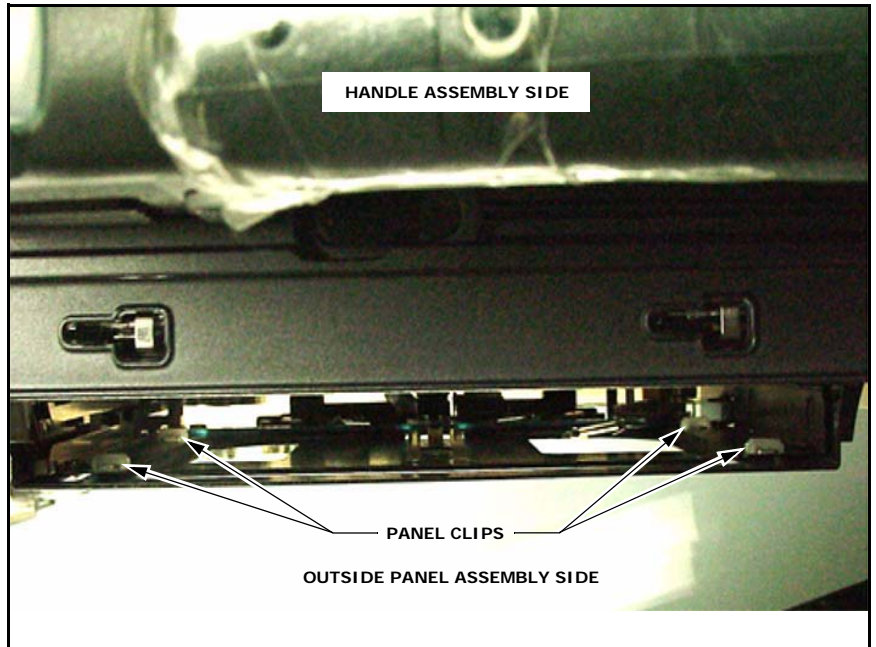
Figure 1

A cartridge may not be detected when inserted. As a result, the unit repeats load and unload operations.

The symptom occurs if the panel clips in the P1 loader assembly are missing. The clips are used to hold the cartridge down.

1. Open the cartridge door of the outside panel, and press the inner shutter down.
2. Confirm that the four panel clips of the P1 loader are installed correctly. (See Figure 1.)
3. If any panel clips are missing, replace the P1 loader assembly (RP) with a new one.
